Wojciech JAKUBICKI\*, Jerzy KĄTCKI\*\*

INVESTIGATIONS OF DEFECTS  
IN EFG CRYSTALLINE SILICON RIBBONS

**A b s t r a c t.** This paper describes the structure of EFG silicon ribbons made in Poland. Twin boundaries, twin lamellae, dislocations, and high- and low-angle grain boundaries were found to occur in the crystals obtained. The investigations showed that graphite used for dies was largely responsible for the rise of these defects.

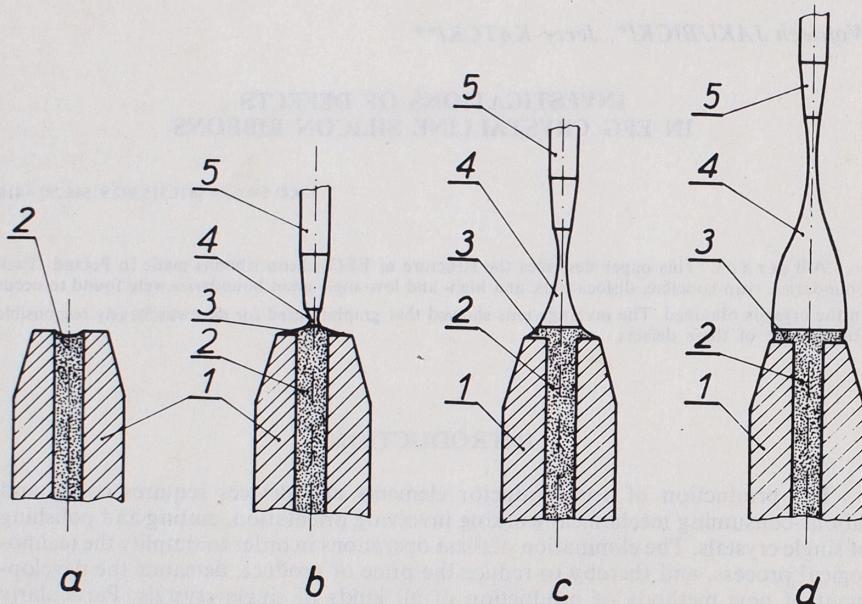
Fig. 1. Initiation of the crystallization of EFG silicon ribbons

1 - die, 2 - capillary filled with liquid silicon, 3 - liquid silicon layer, 4 - crystal, 5 - seed; a - filling of the capillary with liquid silicon, b - bringing the seed into contact with the liquid silicon layer spread over the die surface, c - neck formation, d - expansion of the crystal at increasing pulling rate

Fig. 1 shows the initiation and course of the initial stages of ribbon formation. The stage of stable growth (Fig. 1d) begins when the liquid silicon layer reaches the outer edges of the die.

Fig. 1. Zainicjowanie procesu krystalizacji taśm krzemowych metodą EFG

1 – matryca, 2 – kapilara wypełniona ciekłym krzemem, 3 – warstewka ciekłego krzemu, 4 – kryształ, 5 – zaródź; a – wypełnienie kapilary ciekłym krzemem, b – zetknięcie zarodzi z warstwą ciekłego krzemu, rozlaną na powierzchni matrycy, c – utworzenie przewężenia (szynki), d – rozszerzanie się kryształu przy zwiększeniu szybkości wyciągania

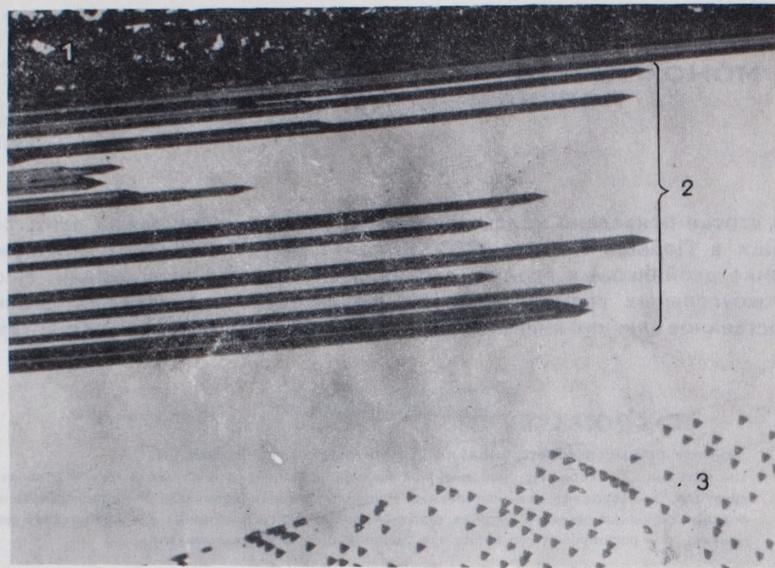
Phot. 1. A fragment of defect structure of the silicon ribbon  
 1 – dislocation pile-ups, 2 – twin lamellae, 3 – dislocation etch pits arranged in lines.  $\times 50$

Phot. 1 shows a fragment of the ribbon surface with visible dislocation pile-ups, dislocation etch pits arranged in lines and twin lamellae. Phot. 2 is a scanning electron micrograph of a fragment of the silicon ribbon fracture and its lateral surface with visible parallel twin boundaries. The position of the twin boundaries shows that the orientation of the ribbon differs from the initial orientation of the seed due to earlier twinning.

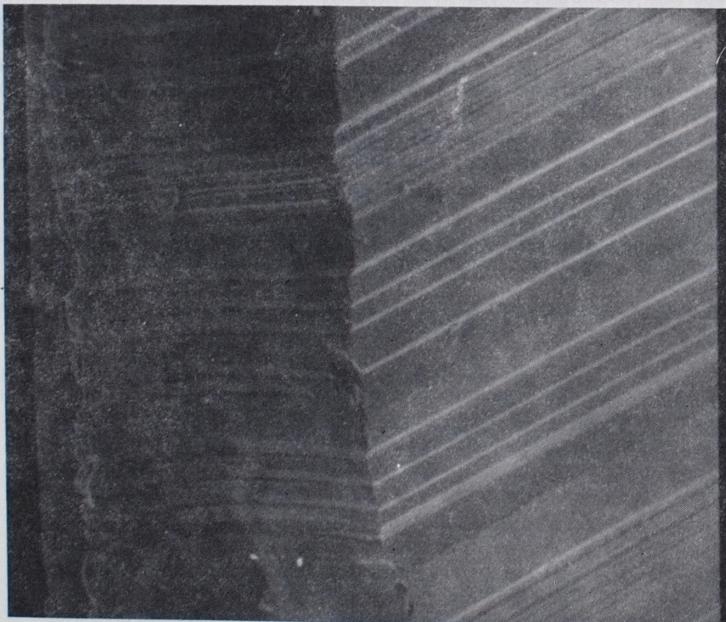
Phot. 2. A series of parallel twin boundaries running along the crystal, observed in the fracture (left part) and at the ribbon surface (right part). SEM,  $\times 100$

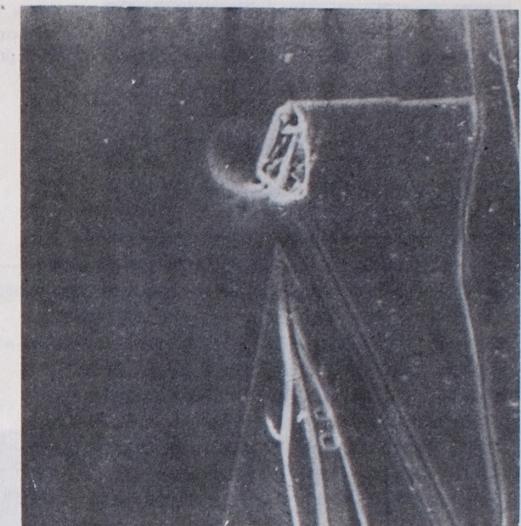
Phot. 3. Twin lamellae and high-angle grain boundaries owing their origin to the presence of graphite inclusion in the liquid silicon layer SEM,  $\times 260$

The material used for dies affects significantly the structure of ribbons. One of such materials is graphite. Due to the erosive action of liquid silicon on graphite, graphite grains are detached from the capillary surface, becoming inclusions in liquid silicon. As a result of reactive diffusion on the surface of graphite being in contact with liquid silicon, a thin layer of silicon carbide forms at the capillary surface. This layer is also subject to erosion and, in consequence, silicon carbide inclusions get into liquid silicon. It has been found that the graphite and silicon carbide inclusions present in liquid silicon are responsible for the formation of twin lamellae and high-angle grain boundaries in the crystal during its growth (Phot. 3). Small silicon carbide crystals discernible at the ribbon surface (Phot. 4) formed as a result of silicon carbide inclusion getting to the edge of the solidification front. The mechanism of formation of silicon carbide and graphite inclusions and of silicon carbide crystals was discussed in a separate paper (Ciszewski *et al.*, in press).

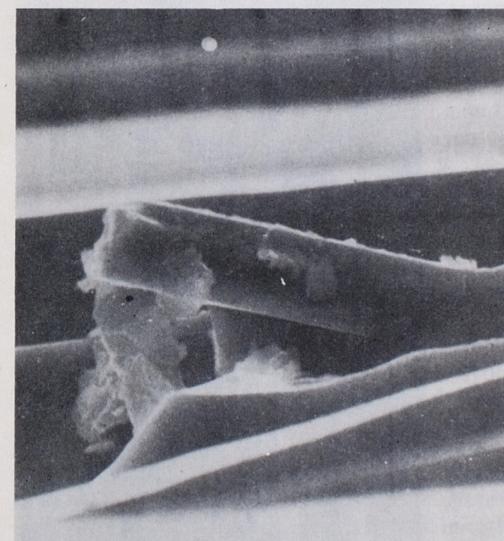
Phot. 4. A characteristic silicon carbide crystal observed at the silicon ribbon surface. SEM,  $\times 2500$

- Фот. 4. Характерный кристаллик карбида кремния, наблюдаемый на поверхности кремниевой ленты. СЭМ. Увел. 250 ×
- Фот. 5. Нарушение равномерной конфигурации ленты, наблюдаемое на ее боковой поверхности, возникшее в результате присутствия в ленте поперечной двойниковой границы. СЭМ. Ув. 100 ×

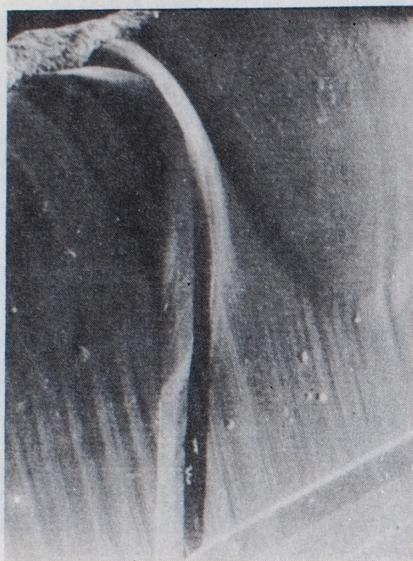
Phot. 5. Disturbance of the regular shape of ribbon observed at its lateral surface, due to the presence of a transverse twin boundary in the ribbon. SEM,  $\times 100$

The generation of transverse twin boundaries in the ribbon results in a change in its initial orientation. This change in orientation is attended by a change in the meniscus angle  $\varphi_0$ , due to which the regular shape of the lateral ribbon surface is disturbed (Phot. 5).

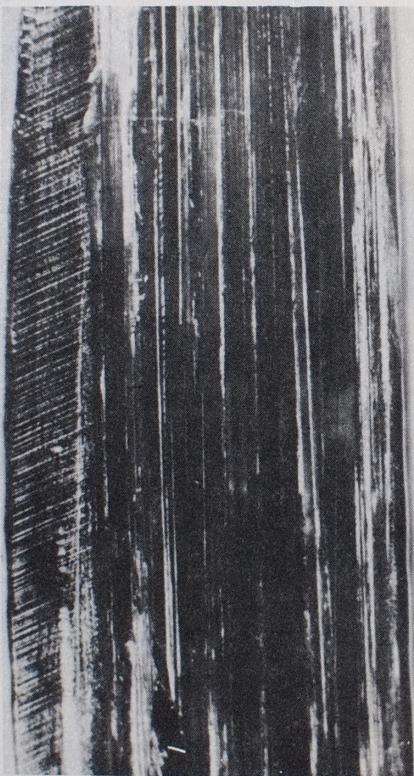
Phot. 6. Ridges formed at the flat ribbon surface at high growth rates

At rapid growth rates (over 10 mm/min.), characteristic ridges form at the ribbon surface (Phot. 6) due to constitutional supercooling taking place under such conditions (Surek *et al.*, 1977).

- Фот. 6. Микроканавки образовавшиеся на плоской поверхности ленты при больших скоростях роста
